# Post Construction iRAP Assessment, India

Mehsana – Himmatnagar SH-55, Gujarat  
April 2019

The Mehsana-Himmatnagar road (SH-55) was assessed post-construction in April 2019. This brief report shows the baseline and as built Star Ratings and comparison of key road infrastructure risk attributes.

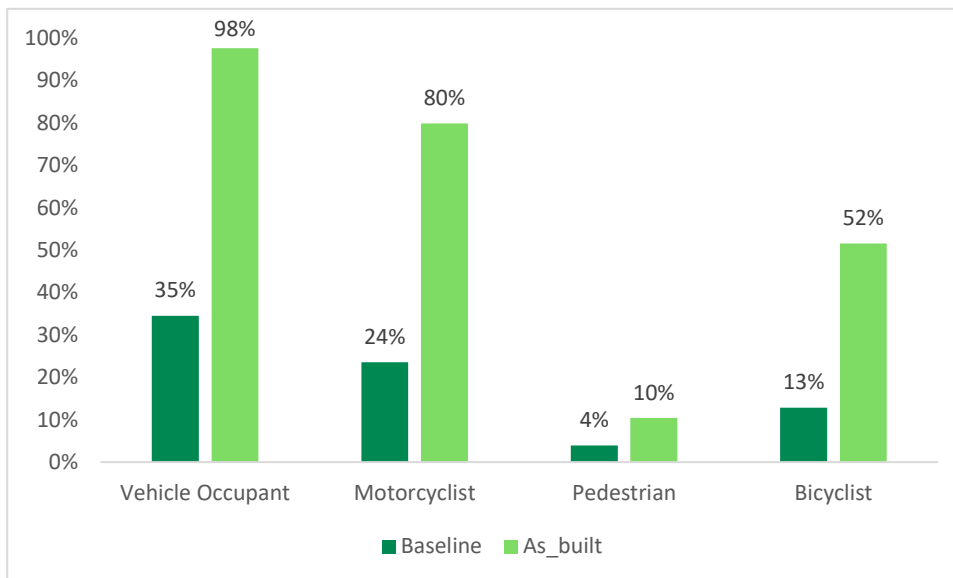
**Figure 6 3-star or better road length for Mehsana-Himmatnagar SH55, Gujarat**

The Star Ratings show significant improvement in the 3-star or better road length for all road users except pedestrian, however there is significant reduction in road length rated 1-star from 82% in baseline to 33%. The road sections where significant pedestrian movement is present is the urban area through which the road is passing.

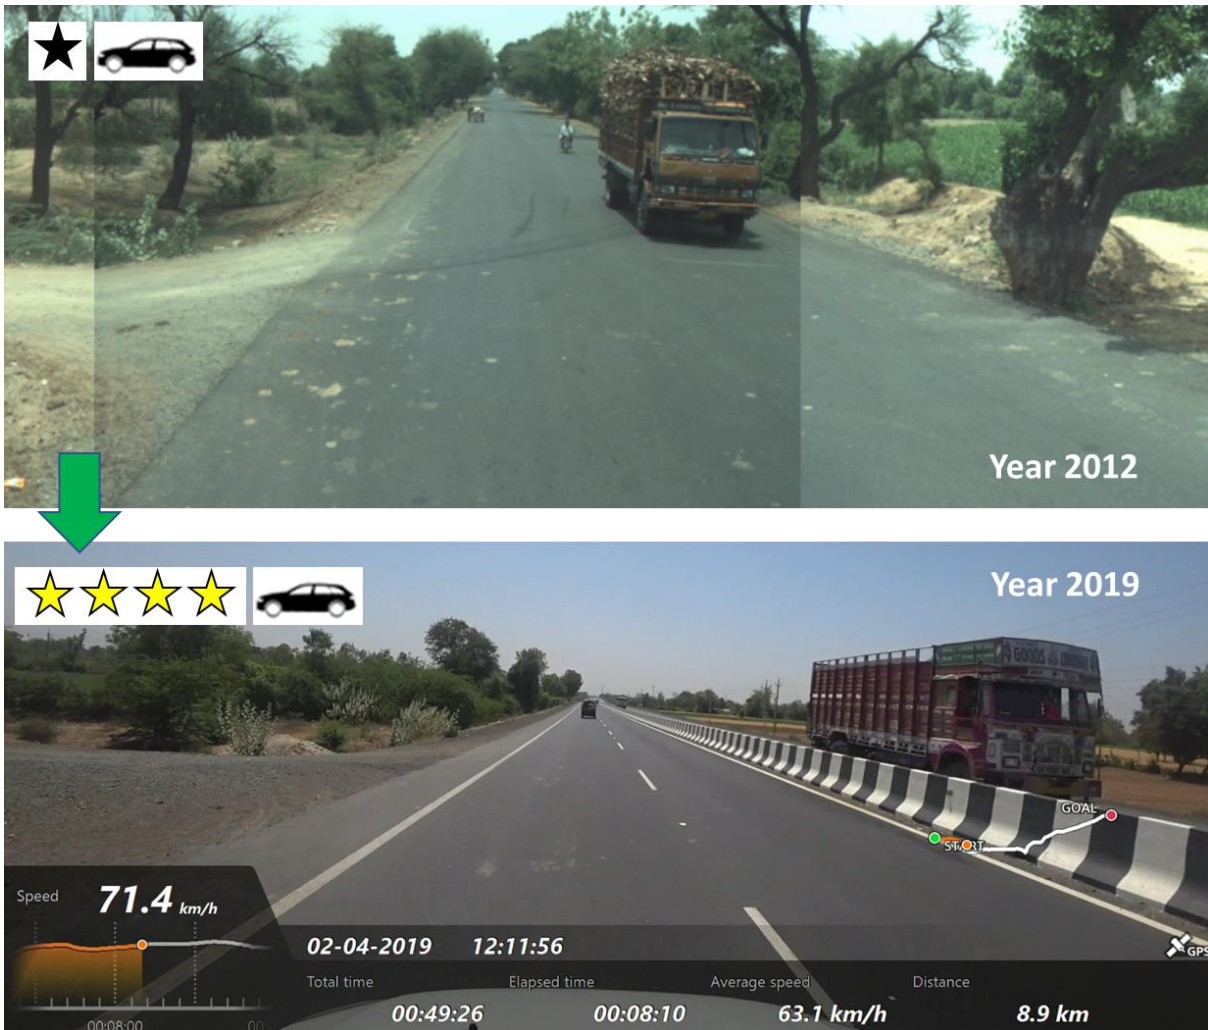
**Figure 11 Before and after improvement road image, Km 118.3**

The new improved road facility is 4-lane wide road with concrete barrier in the median which eliminates the risk of head-on collision. The improved road has got adequate delineation (road markings and signages), paved shoulders and earthen shoulders which reduces the run-off crash risk.

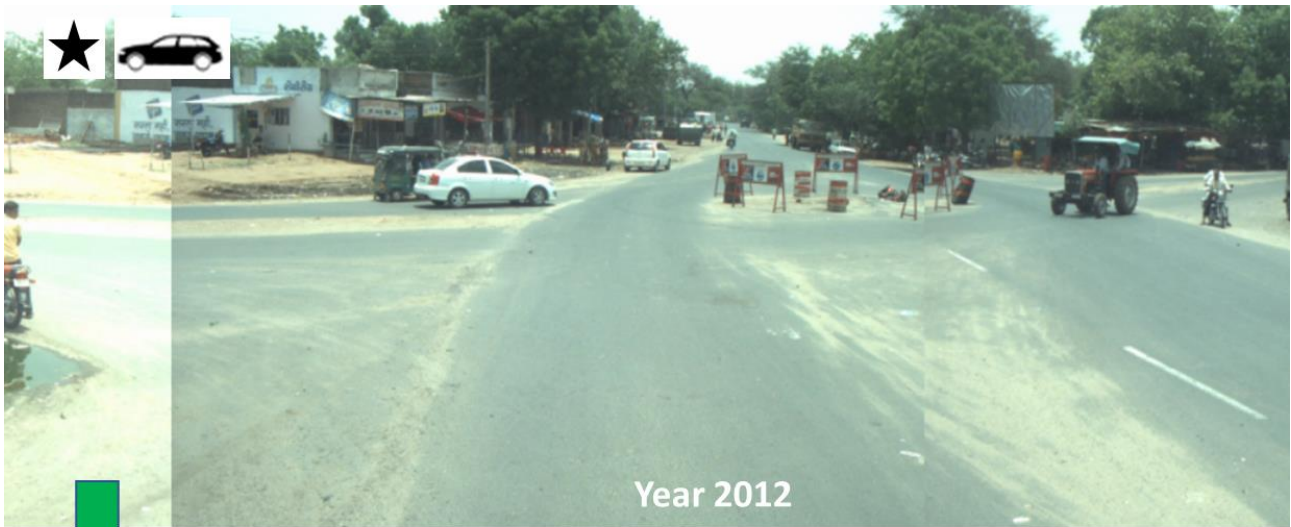
**Figure 12 Before and after improvement image of intersection, Km 126.9**

The four-leg intersection shown in the above image has been replaced by a well-designed roundabout with splitter islands and crossing facility for pedestrian. The roundabout is safe treatment for an intersection as it reduces the vehicle-vehicle conflict points and also the vehicles approaching a roundabout need to slowdown. The roundabouts on this road are provided with streetlights and blinkers to catch attention of approaching drivers.

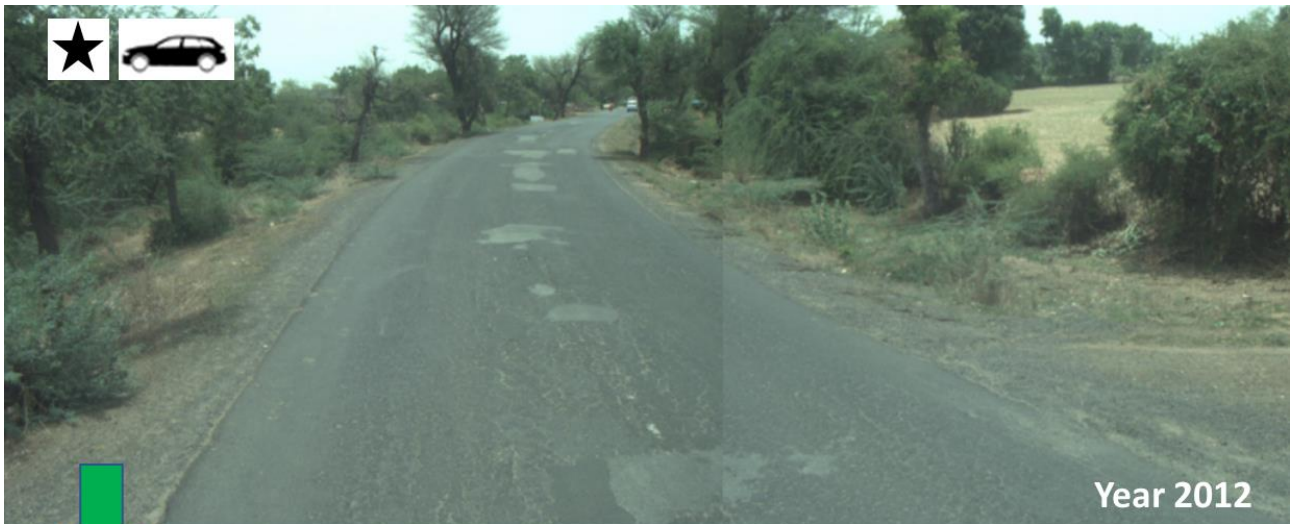
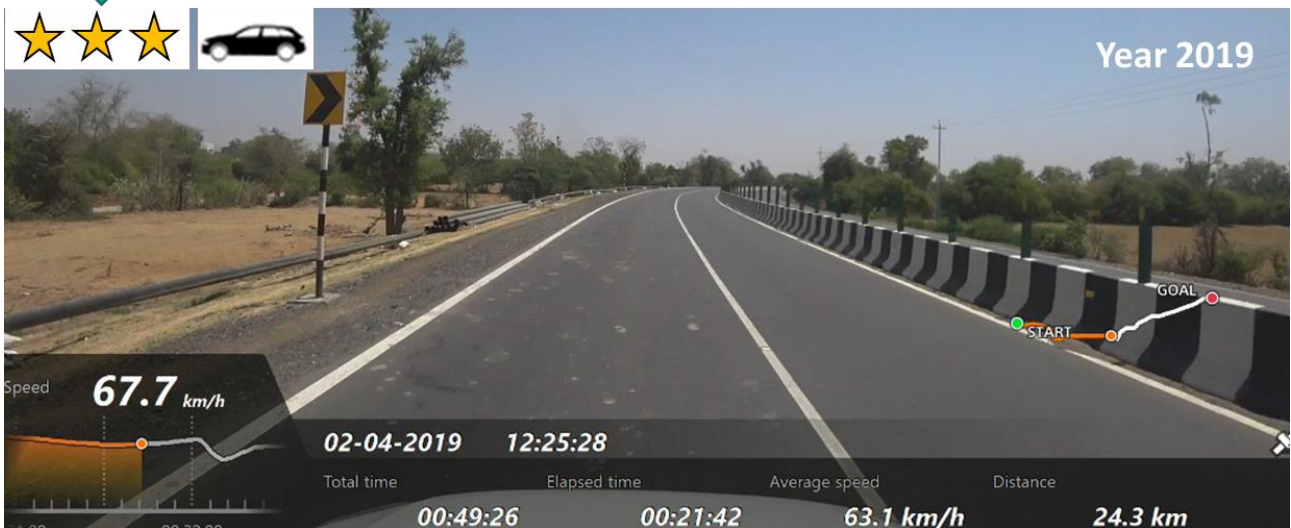
**Figure 13 Before and after improvement image of curvature, Km 133.7**

All horizontal curvatures, as shown in the image above, have been provided with better delineation. The chevron signs provided on the outer edge and improved road markings reduces risk of run-off crash on such curvatures. The concrete barrier in the median eliminates head-on risk thus minimizing overall risk on road sections having such curvatures.

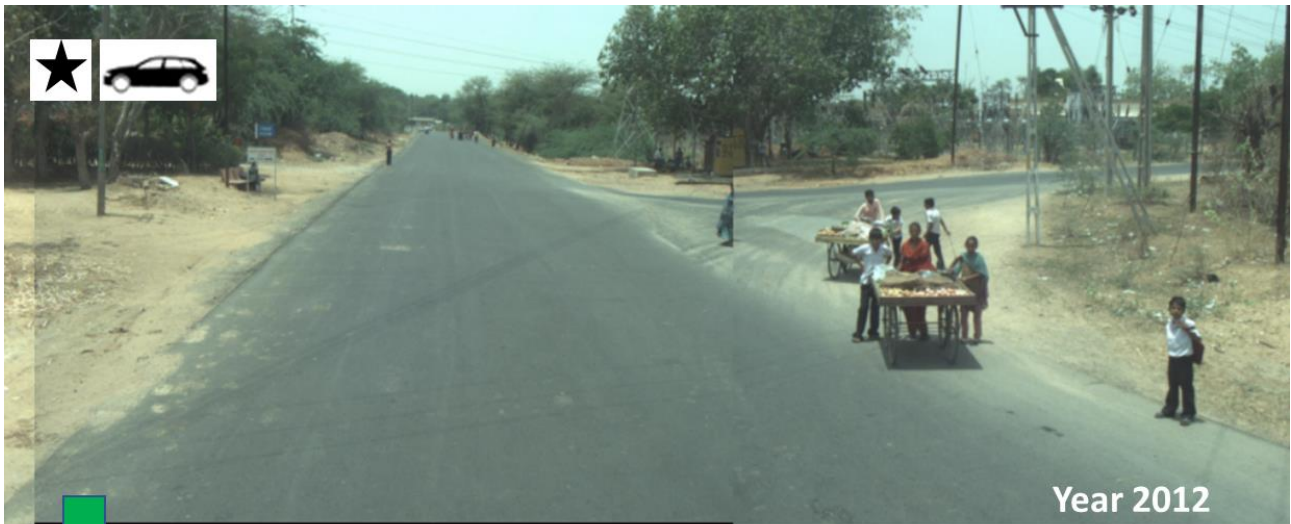
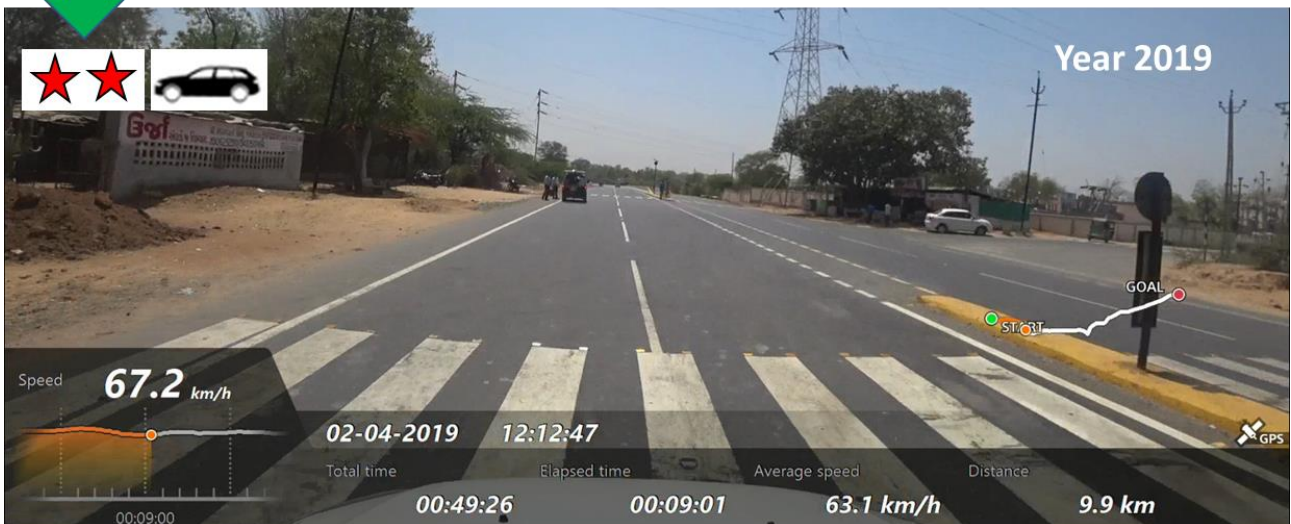
**Figure 14 Before and after improvement image of intersection, Km 119.3**

Three-leg and four-leg intersections have been improved with lane markings and signages. The major intersections have been provided with streetlights. The image above shows the improved intersection still gets 2-star which is result of narrow median and having no turn-lane for right turning vehicle. On such intersection, there is risk of waiting vehicle being hit from rear.

**Intersection improvement:** As described above, the narrow width of median at intersections may become hazard. Ways to widen the median in intersection area (e.g. to have additional width of 1.5m on both sides by widening the road on outer side in the intersection area – that makes the median 3m wide) must be explored.

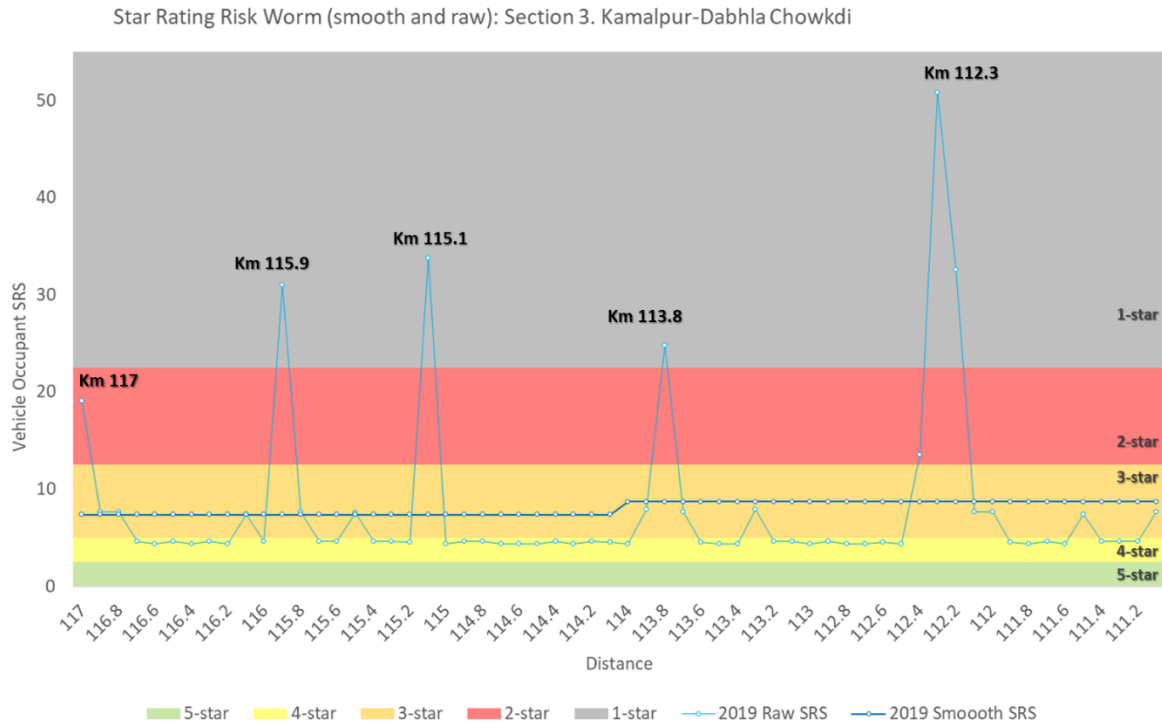
**Figure 16 Risk worm showing smooth and raw SRS for Section-3 of Mehsana-Himmatnagar road**

A Star Rating Score (SRS) is calculated for each 100metre segment of road for vehicles occupants, motorcyclists, pedestrians and bicyclists. These scores are then allocated to Star Rating bands to determine the Star Rating for each 100metre of road. However, for the purposes of producing a network level map showing Star Ratings, 100metre segment is too much detail. Hence, Star Ratings are smoothed (or averaged) over longer lengths in order to produce more meaningful results. The effect of smoothing is illustrated in the chart below, which shows risk-worm for Section-3 of Mehsana-Himmatnagar road. The raw Star Rating Scores (SRS) are shown in light blue and smoothed SRS in dark blue colour.

The spikes with raw SRS indicate road segments where the risk is higher. The first such spike is Km 117 which is 2-star location and other four such spikes are 1-star locations. These are intersections and the image given below for 3-leg intersection at Km 112.3 shows the road has narrow median and lack of right turning lane increases the risk of rear-end collision for vehicles waiting to turn.

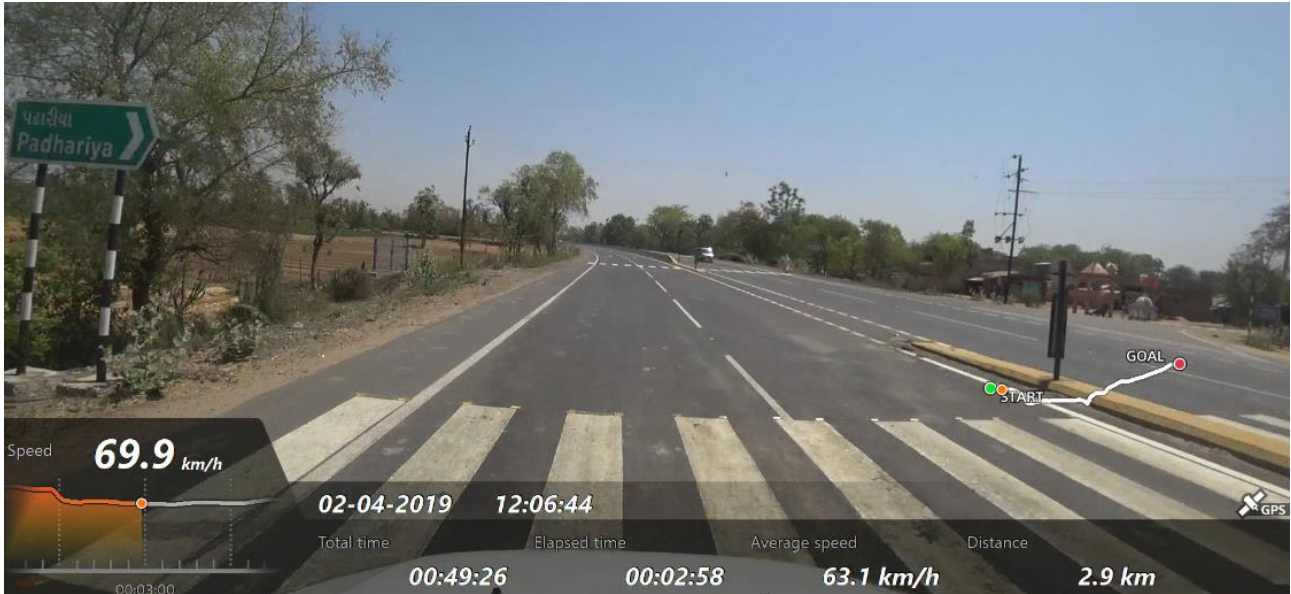
**Figure 17 Three-leg intersection without turn-lane, Km 112.3**

The road has been widened from 2-lane to 4-lane with limited Right-of-way hence the median has been kept as narrow as possible hence none of the intersection are provided with turn-lanes. This results into such intersection getting 1-or 2-star. However, the average risk of each road section is lower hence the smooth Star Rating tends to be 3-star or better as shown in the risk worm above. This is resulting into majority of road length getting 3-star or better for vehicle occupant and motorcyclist.

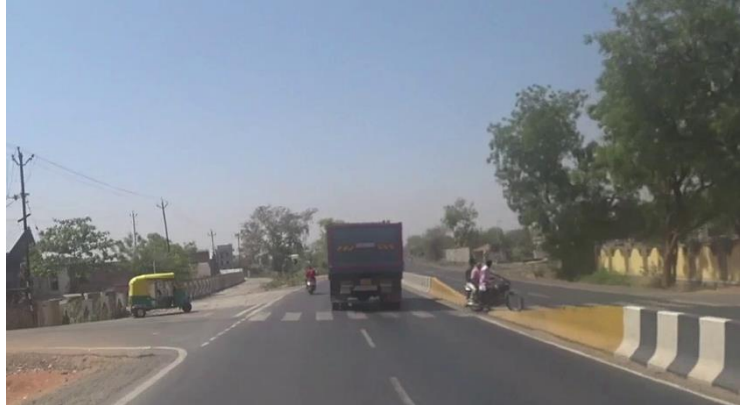
The upgraded road Mehsana-Himmatnagar SH55 eliminates head-on collision risk between the opposite flow of traffic as the road has been converted to dual carriageway (except a bridge and two railway crossings) with provision of concrete barrier in the median. The quality of intersections has been improved, the geometry of existing roundabouts has been improved, some intersections have been converted to roundabouts which reduces the risk of intersection related crashes. However, the narrow median barrier at intersections are still a concern for safety as it poses high risk of vehicles, waiting to take turn, being hit from rear as shown in a sample image of such intersection.

*Narrow median width is hazardous for vehicles taking turn. The motorcyclist waiting in the median may hit by any vehicle from the rear or side.*
