Post Construction iRAP Assessment, India

Belgaum – Yaragatti SH-20, Karnataka
April 2019

The Belgaum – Yaragatti road (SH-20) was assessed post-construction in April 2019. This brief report shows the baseline and as built Star Ratings and comparison of key road infrastructure risk attributes.

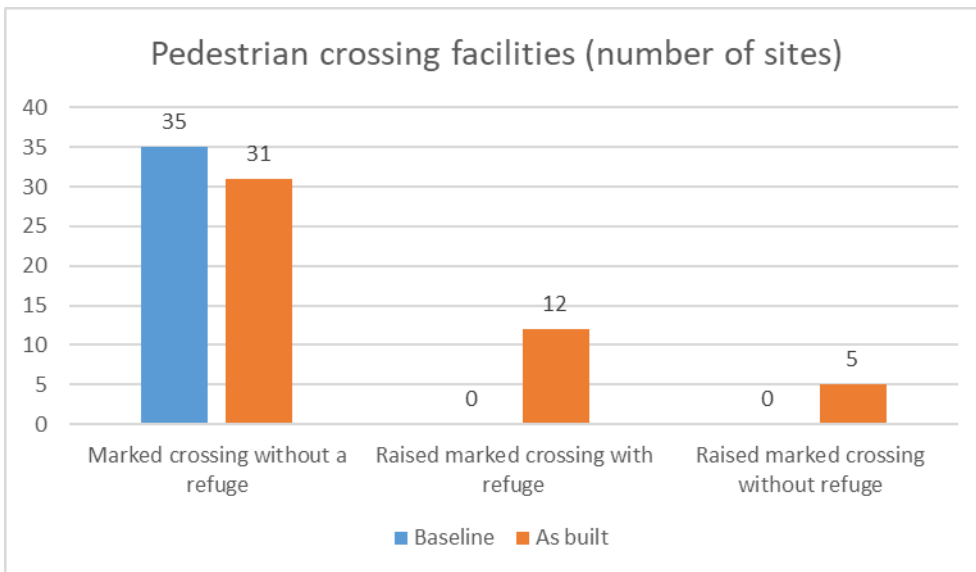
Figure 2 Pedestrian crossing facility type

The improved SH20 includes raised (or table-top type) pedestrian crossings near major intersections and areas where frequent pedestrian cross flow occurs. This gives pedestrians a safe way to cross the road and also act as a traffic calming measure as the approaching vehicles slow down.

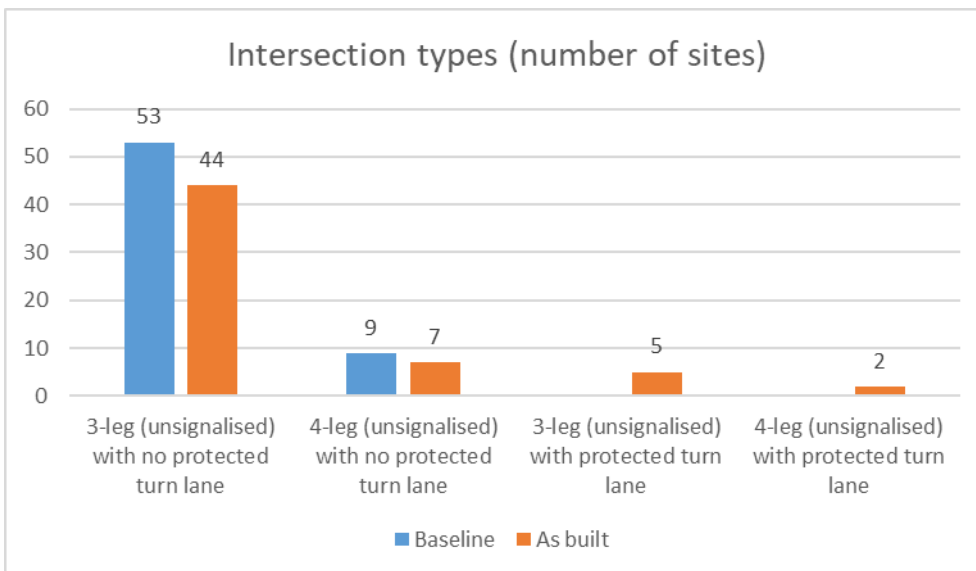
Figure 3 Intersection type

Seven major intersections on this road have been redesigned with a right turning lane and channelization (median in the intersection area). The turn lane reduces the risk for turning vehicles being hit from the rear while waiting to take a right turn. The physical median on the main road in the intersection area helps to channelize the flow.

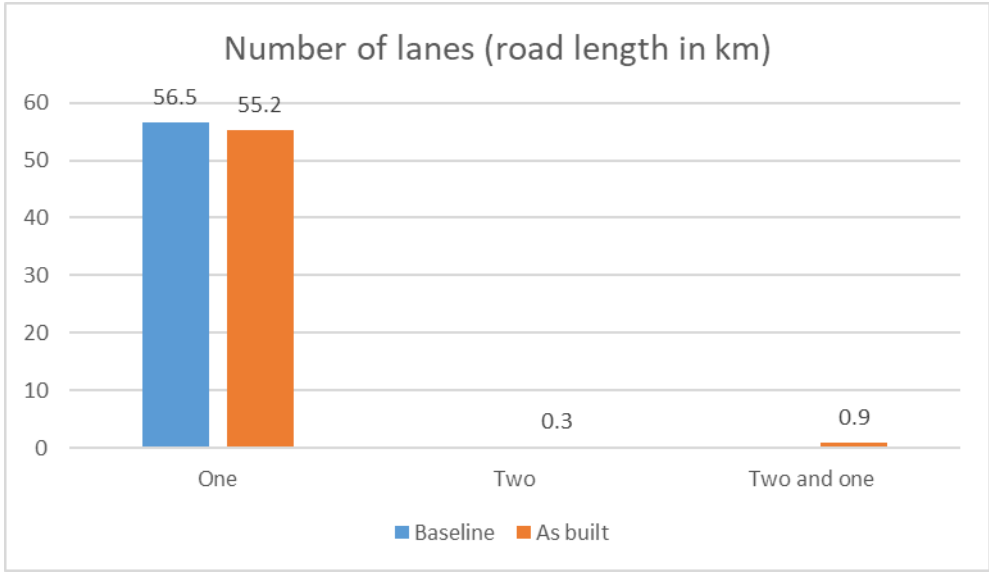
Figure 4 Number of lanes

The hill road section has been provided with 2+1 lanes so that it gives enough opportunity to fast vehicles to overtake the slow-moving/heavy vehicles. Some portion of the road in urban area has got 2 lanes in each direction to cater for slow-moving vehicles like bicycles, rickshaws, etc.

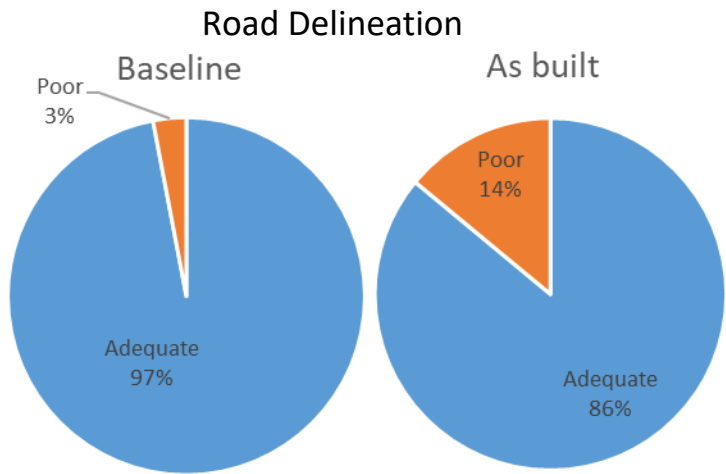
Figure 5 Road delineation

The road delineation that mainly includes road markings and signs is of adequate quality for 86% of the road length compared to 97% of road length in baseline. This seems to be contrary to the road improvement. This is mainly because the road surface and lane markings of few sections of the road were not improved as part of the project. The stretches listed below have medium/poor road surface condition and/or poor delineation,

- Km 15.1 - 17.8;
- Km 22.2 - 24.4; and
- Km 26.2 - 28.1

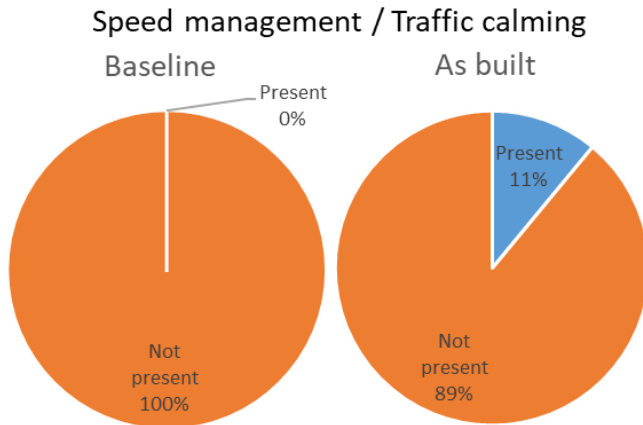
Figure 6 Speed management measures

The improved road has traffic calming measures like painted yellow stripes across the road and raised pedestrian crossing. These are effective in making the drivers alert of the road situation and to slow down. Major intersections have been provided with yellow painted strips and raised (table-top) crossings on both sides which effectively reduces the vehicle speeds to around 40kmph in such zones.

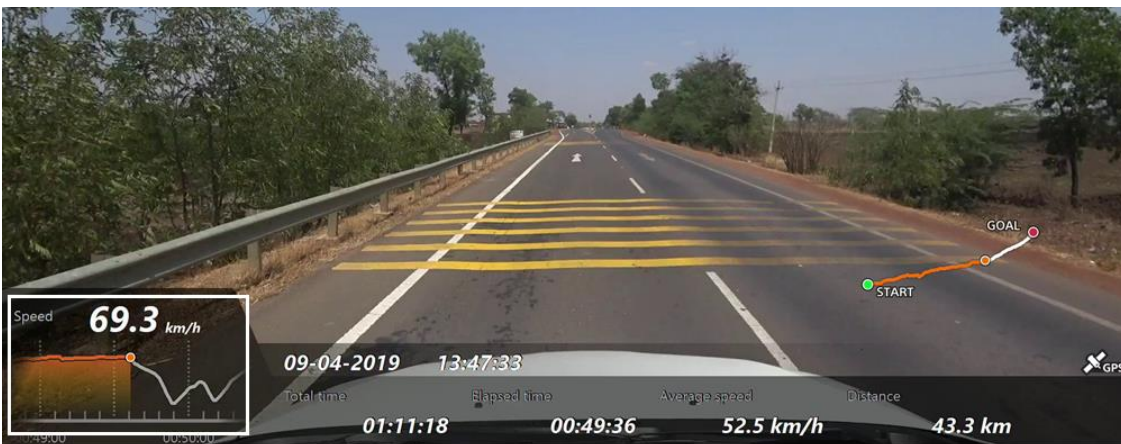
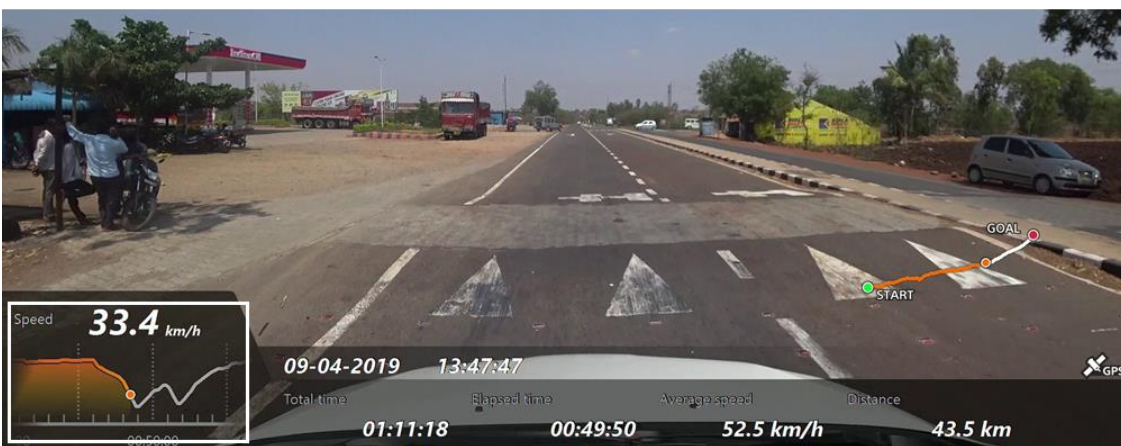
Figure 7 Effective speed management on major intersections

The figure below shows yellow painted strips across the road on approach of a major intersection and the table-top crossing acting as a traffic calming measure reduces the vehicle speed to around 40kmph in the intersection area. The painted strips and markings on the raised pedestrian crossing should be inspected and renewed periodically if worn. The markings in image given below shows slightly worn which may need to be renewed soon.

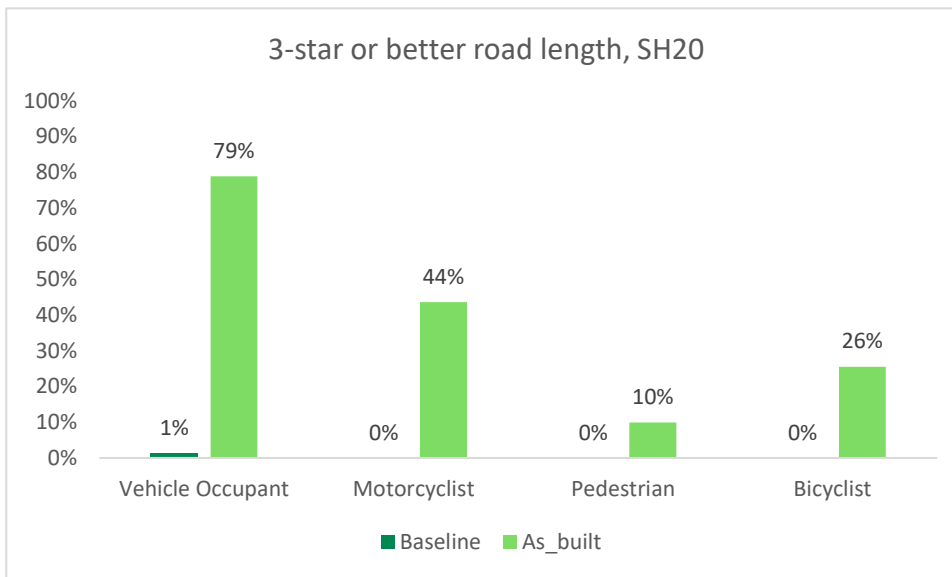
Figure 8 % road length with 3-star or better ratings

The Star Ratings show significant improvement in the 3-star or better road length for all road users except pedestrian. The road sections where significant pedestrian movement is present is the urban area and major intersections where treatments like pedestrian crossings, footpath and speed management have been provided to improve safety. The chart given below compares % road length with 3-star or better ratings for SH20 before and after improvement.

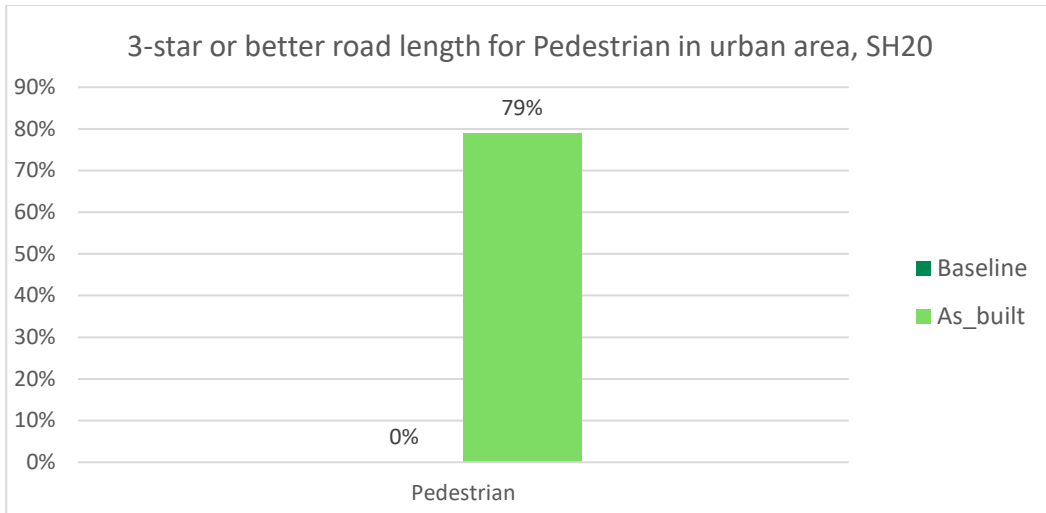
Figure 9 % road length with 3-star or better ratings for pedestrian in urban area

The chart given below shows improvement in safety of pedestrian in the urban area and sections where significant pedestrian movement is present by comparing the road length with 3-star or better ratings before and after improvement of road.

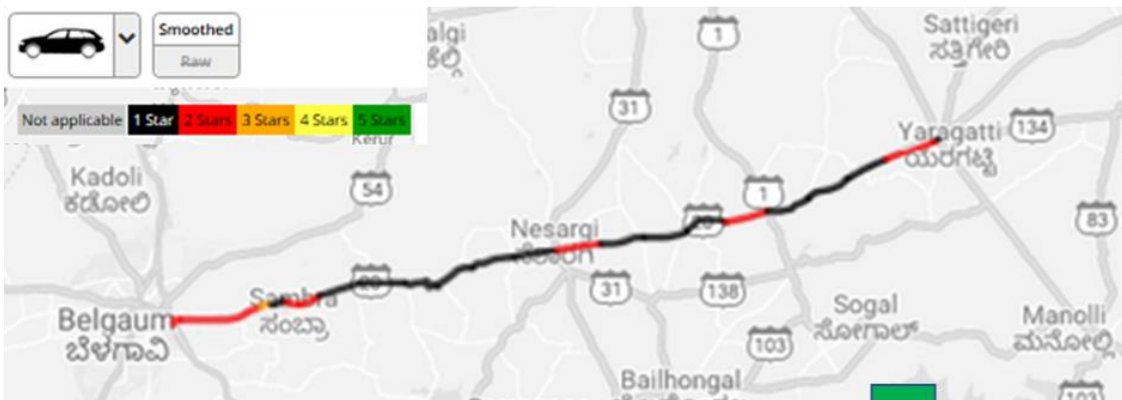
Figure 10 Star Rating map of baseline and as built road for vehicle occupant

The Star Rating maps of vehicle occupant given below compares before improvement and after improvement situation.

Star Rating map of baseline road (before improvement)

Star Rating map of as built road (after improvement)

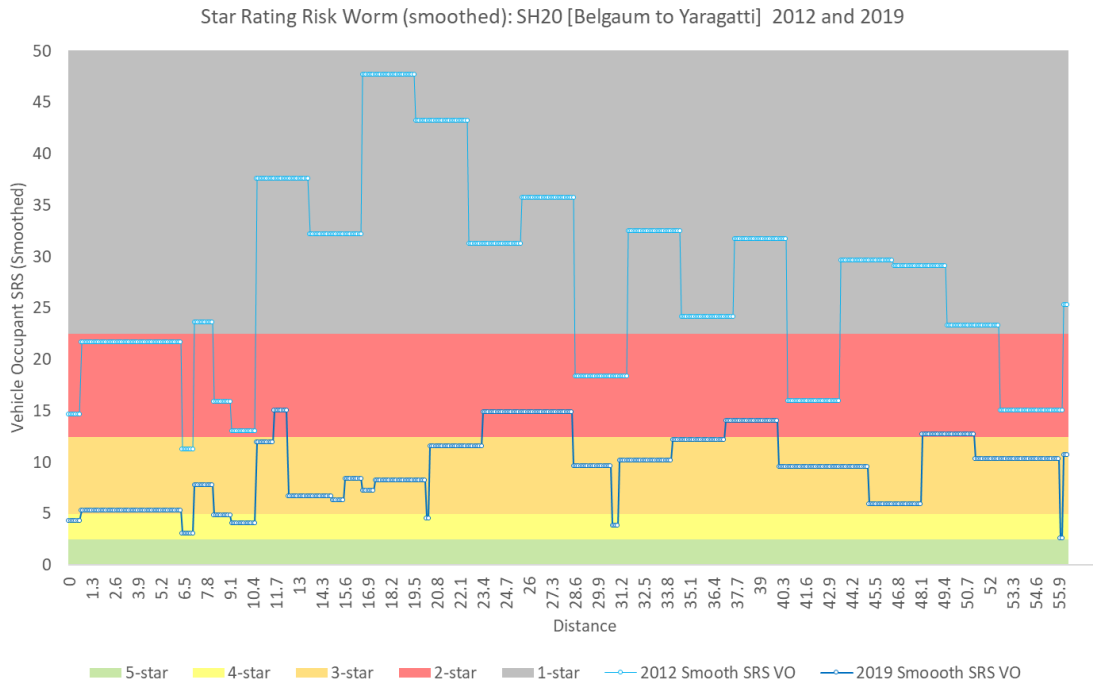
Figure 11 Risk worm showing Star Rating Score for vehicle occupant before and after road improvement

A Star Rating Score (SRS) was calculated for each 100metre segment of SH20 for vehicles occupants, motorcyclists, pedestrians and bicyclists. These scores were then allocated to Star Rating bands to determine the Star Rating for each 100metre of road. However, for the purposes of producing a network level map showing Star Ratings, 100metre is too much detail. Hence, Star Ratings were smoothed (or averaged) over longer lengths in order to produce more meaningful results. The chart (risk worm) with smoothed SRS for

vehicle occupant before and after road improvement is given below which shows significant reduction in risk after road improvement.

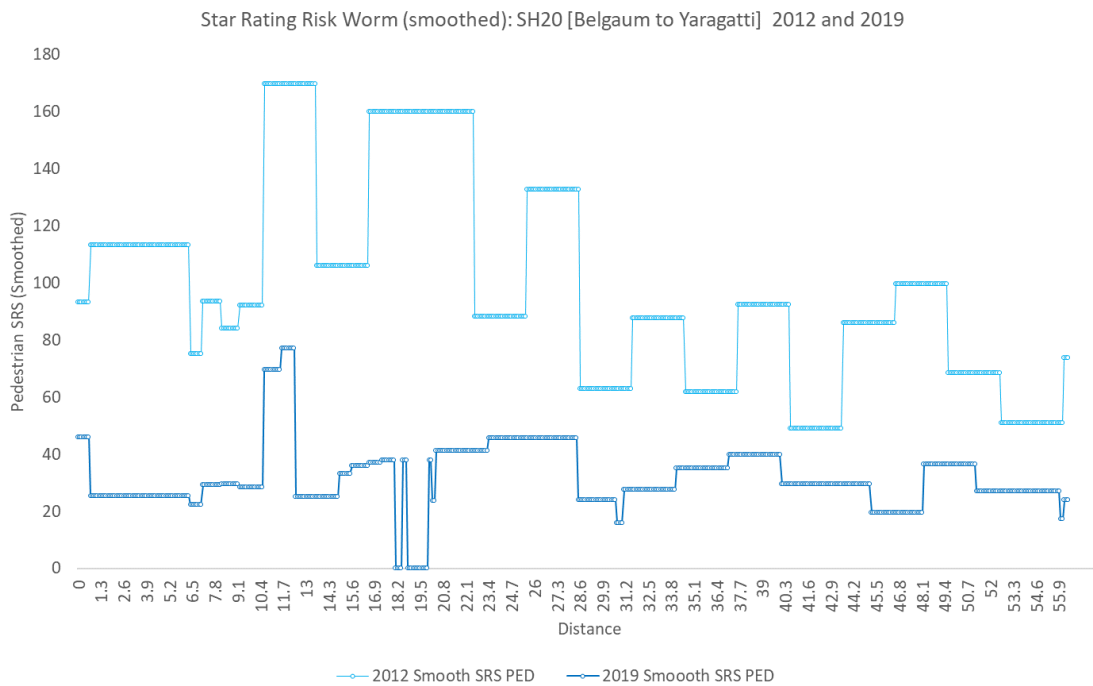
Figure 12 Risk worm showing Star Rating Score for pedestrian before and after road improvement

Similarly, risk worm prepared for pedestrian shows significant reduction in the risk for pedestrian after improvement of the road given below.

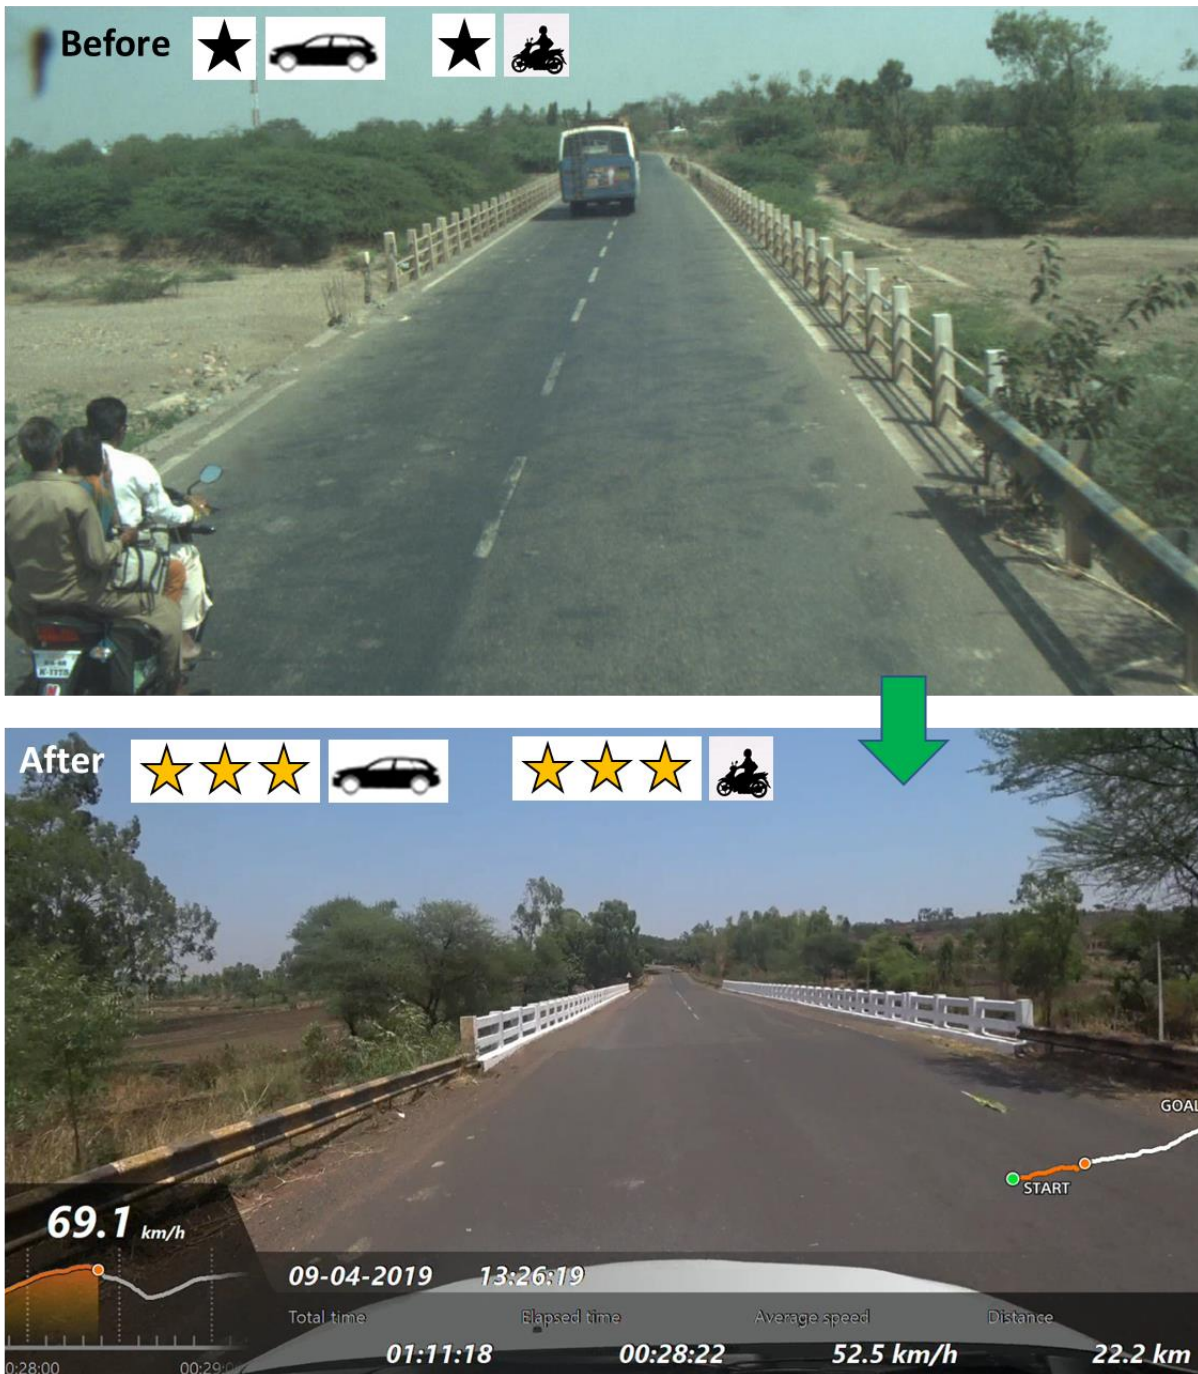
Figure 13 Before and after road improvement image, Km 22.2

The image (before improvement) given above shows broken bridge parapet which poses very high risk of severity in case of a run-off crash. This broken parapet has been fixed and the metal crash barrier has been provided before the bridge parapet. This improves vehicle occupant and motorcyclist Star Rating from 1-star to 3-star. The poor delineation (edge line and centreline markings) was observed at this location and the KSHIP team was informed for improvement under the road maintenance activity.

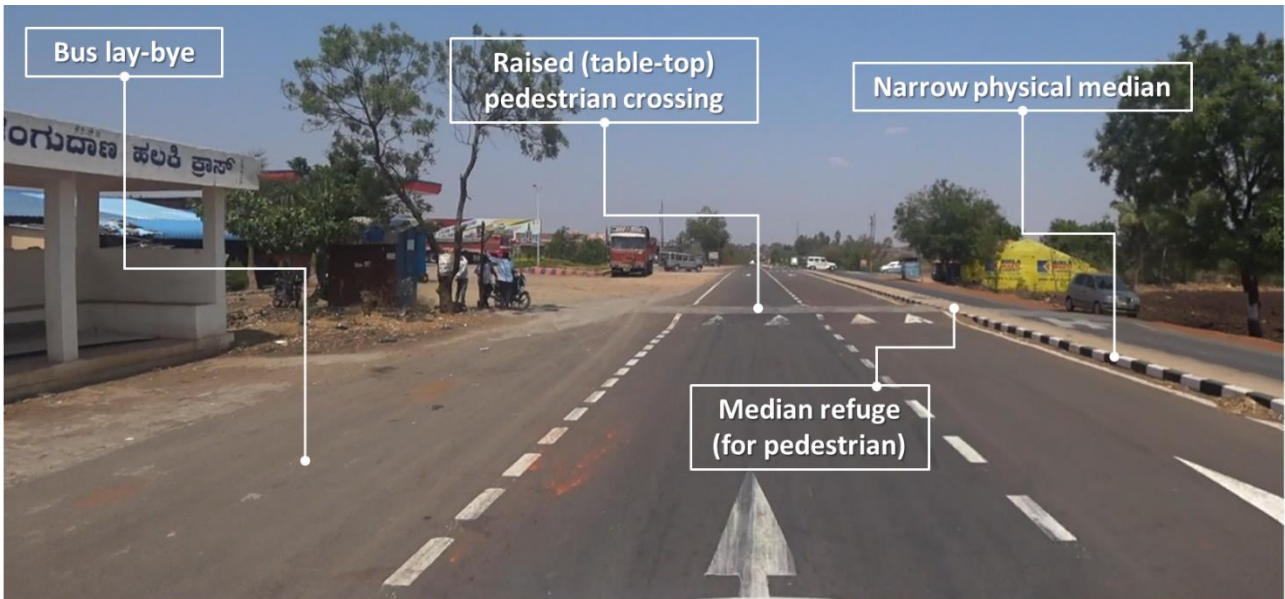
Figure 14 Improved intersection and pedestrian facility, Km 43.5

Key road conditions	Before improvement	After improvement
Facilities for pedestrian	None	Bus lay-bye and Raised pedestrian crossing with refuge space in the median
Road markings	Poor	Adequate
Type of intersection	4-leg intersection	4-leg intersection with additional lane for right-turning vehicles
Intersection markings and signages	Poor	Adequate
Star Ratings	★ ★ ★★ ★★	★★★ ★★★ ★★★ ★★★★

The image given above shows improved facility for pedestrian that includes a bus stop with lay-bye and raised pedestrian crossing with refuge space in the median. The 4-leg intersection at this location has been improved by providing additional lane for right turning vehicles and median/splitter islands. The raised/table-top crossing on each side of intersection and the yellow painted strips across the road proves to be effective speed management measure that brings down the vehicle speeds in intersection area to about 40kmph. The before and after improvement Star Ratings shown above are smooth Star Ratings of the road stretch from Km 43.4 to 43.9 which indicates improved road gets 3-star or better for all four road user groups.

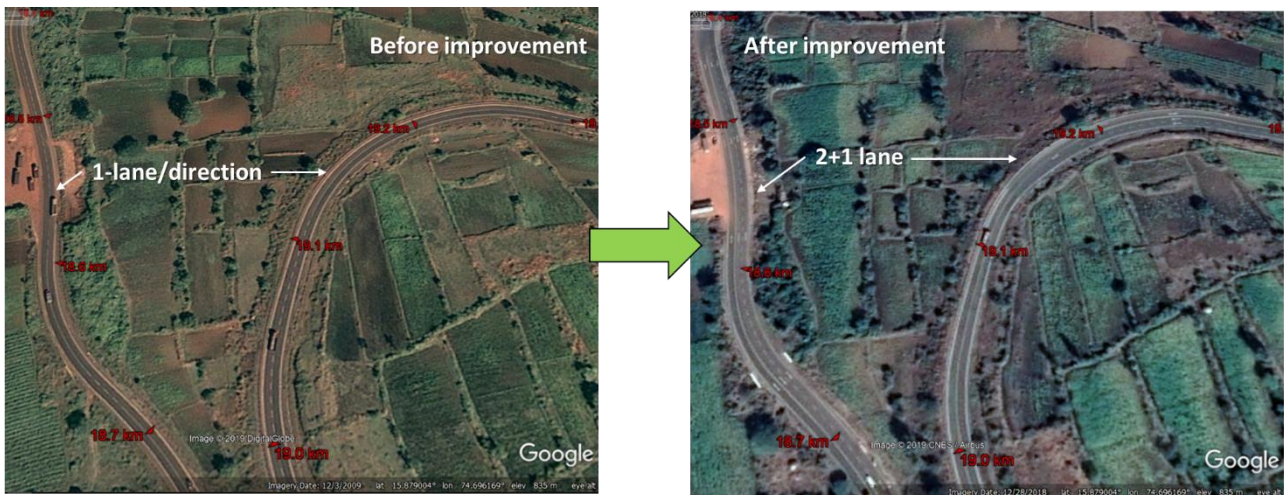
Figure 15 Improved road with 2+1 lane and curve delineation, Km 19.5

Key road conditions	Before improvement	After improvement
Road and curvature markings	Poor	Adequate
Number of lanes	1 in each direction	2+1
Roadside hazards	Trees and steep slope	Metal crash barrier
Star Ratings	★★   ★★  	★★★   ★★★

The road section from Km 18 to 20 is hill road with bends and sharp horizontal curvatures. This part of road has been improved with improved road and curvature delineation and provision of 2+1 lanes. The smooth Star Ratings of this section shows improvement from 2-star to 3-star for vehicle occupant and motorcyclist. Due to very low numbers of pedestrian and bicyclist in this section, Star Rating results are not produced for them.

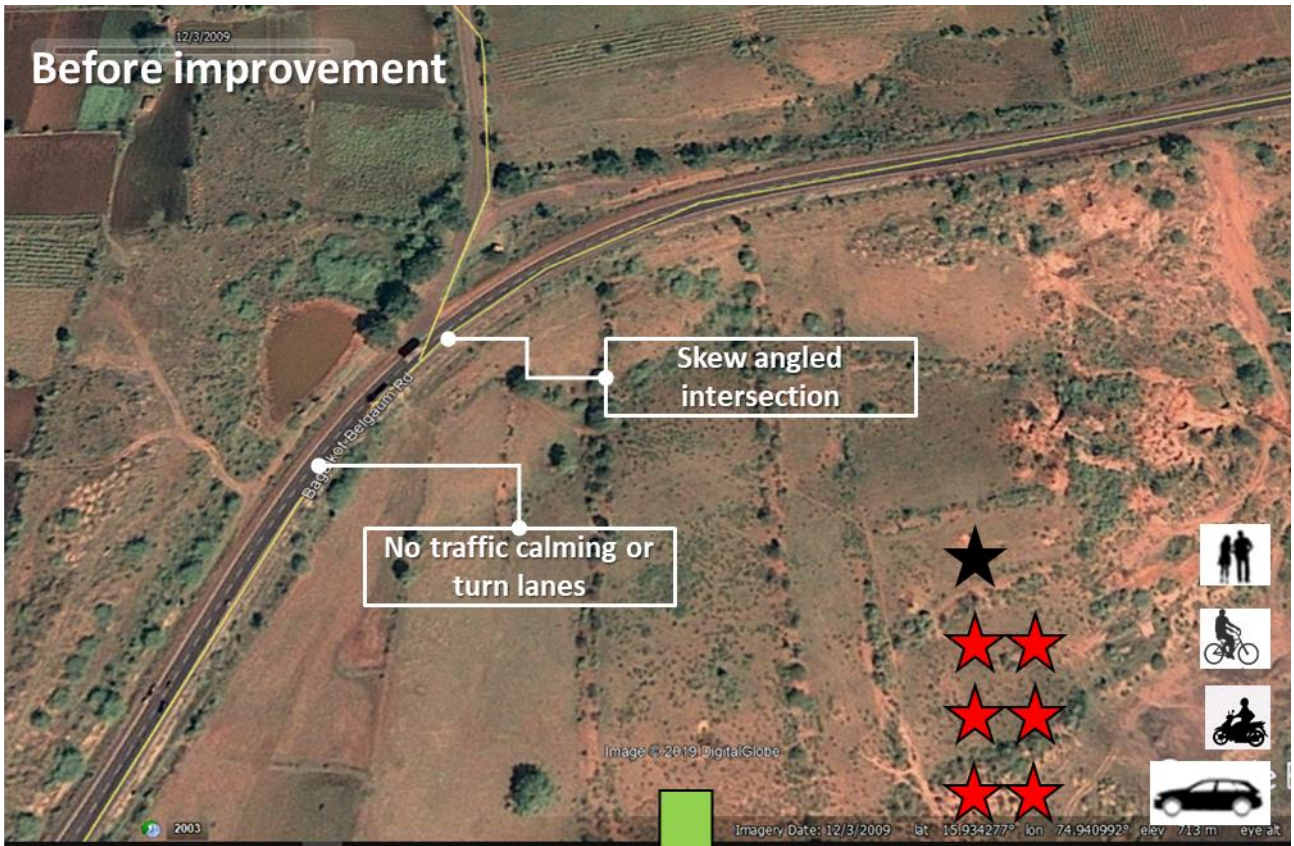
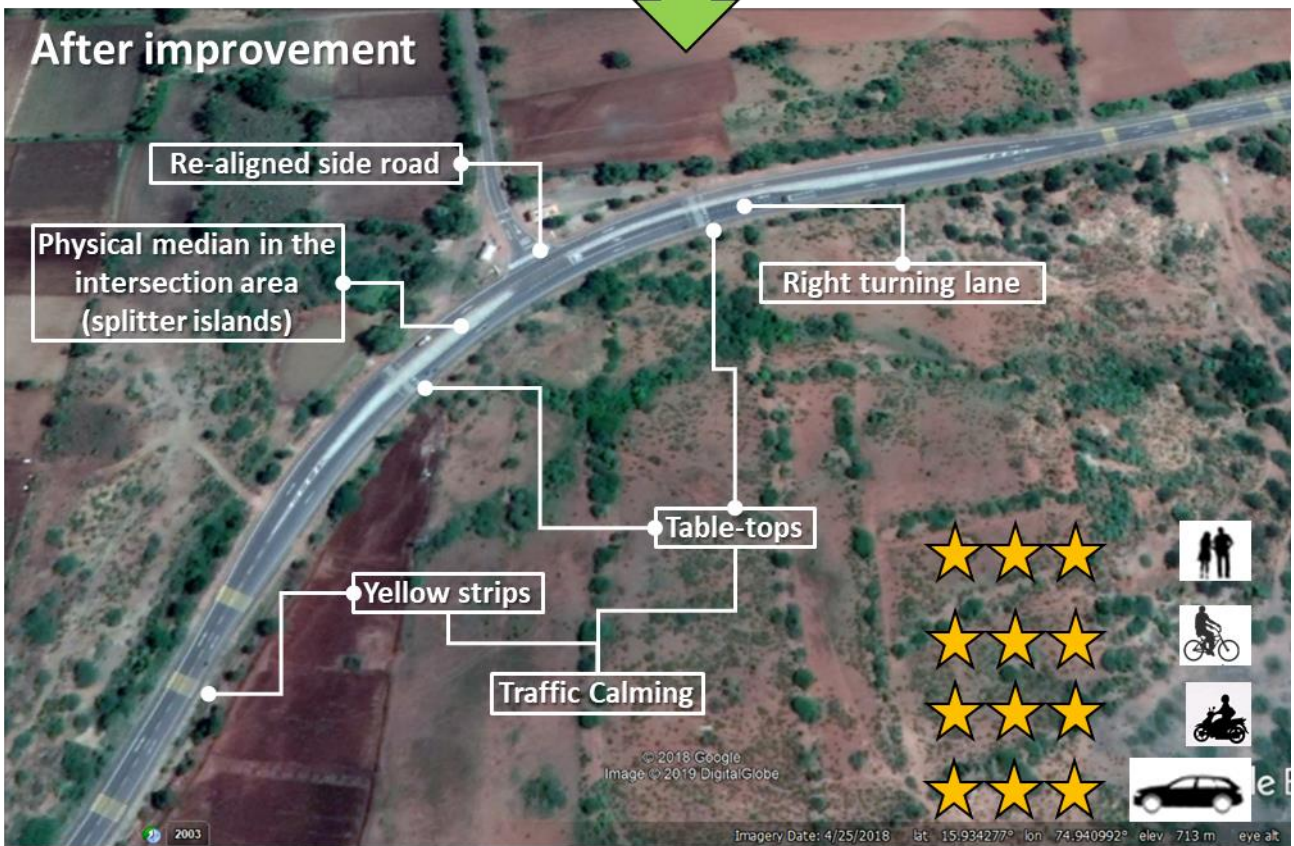
Figure 16 Before and after Improvement image of intersection, Km 46.9

Major intersections on SH20 are improved by providing the traffic calming measures, right-turn lane, physical median (splitter islands), adequate road markings and signs, and pedestrian crossing facilities as shown in the image above. The Star Ratings for all road users increased to 3-star for intersection at Km 46.9.

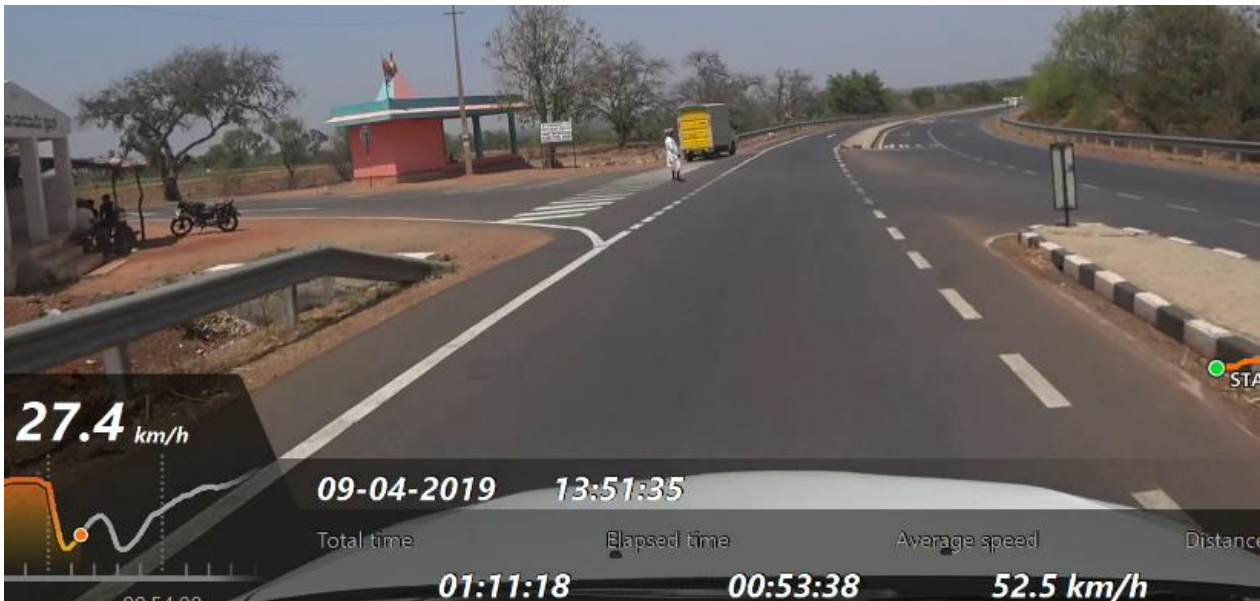
Figure 17 Intersection at Km 46.9

The photograph of improved intersection at Km 46.9 shows features such as right-turn lane, splitter islands, and road markings.

On both the approaches of such major intersections, 4-sets of yellow painted rumble strips and a raised pedestrian crossing are provided as traffic calming measures. This set of treatment seems to be effective as the vehicle speeds in such intersection area was observed to be around 40kmph. The uniform application of such traffic calming measures on all major intersections of SH20 helps the driver to recognize the given road situation and adapt to it by reducing the speed of vehicle.

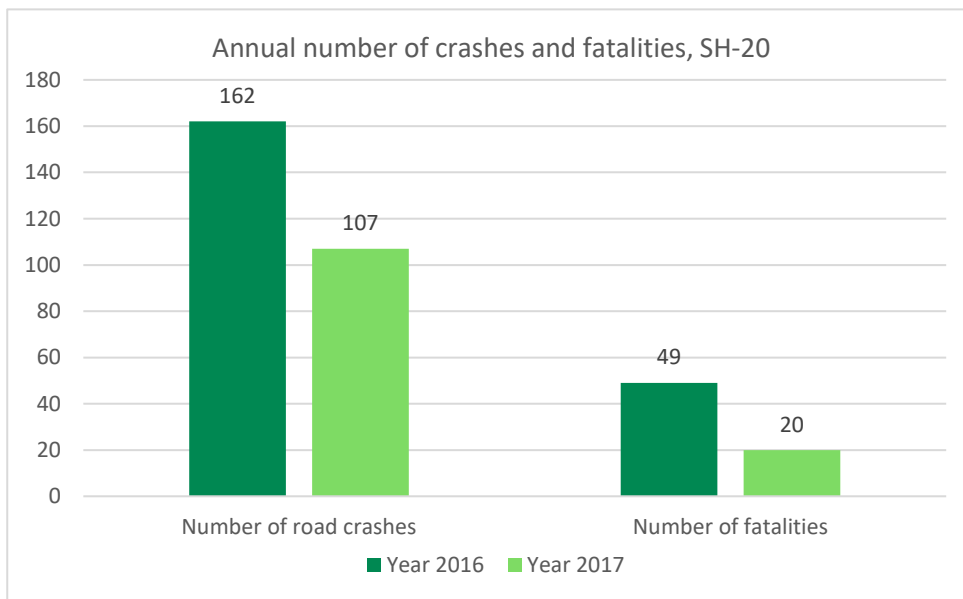
Figure 18 Reduction in number of crashes and fatalities after improvement of SH-20

KSHIP, the implementing road authority, collected road crash data for this corridor and compared the number of crashes and number of deaths before the improvement and after improvement. The number of crashes and persons killed from January 2017 to December 2017 was compared with the previous year data i.e., from January 2016 to December 2016 and it was observed that,

- the number of crashes reduced from 162 to 107, and
- the number of persons killed reduced from 49 to 20,

This shows over 50% reduction in fatalities. This achievement in reduction of crashes and saving lives is achieved due to implementing targeted road safety interventions and the non-engineering measures adopted.

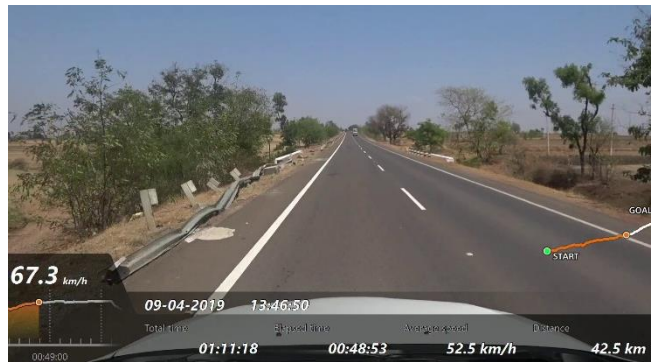
Broken crash barrier Km 42.5, SH-20

Road maintenance: The road must undergo continuous maintenance to keep the road markings and other safety devices in good condition. Evidence of broken crash barriers, pedestrian fence and footpath are shown in images below which must be maintained or replaced.

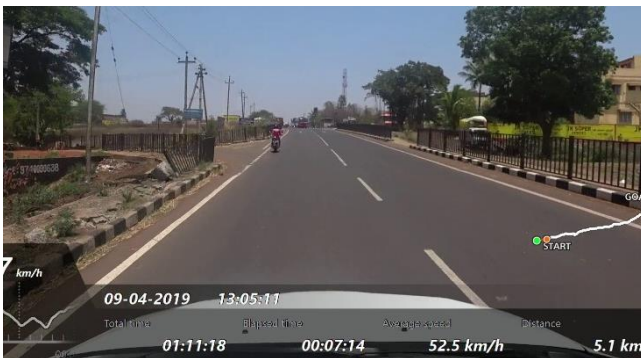
Poor condition of footpath and broken pedestrian fence Km 5.1, SH-20

Road surface and delineation improvement: Improve road surface condition, road markings, shoulders and footpath (wherever exists) in the road sections which are not already included in this road improvement project.

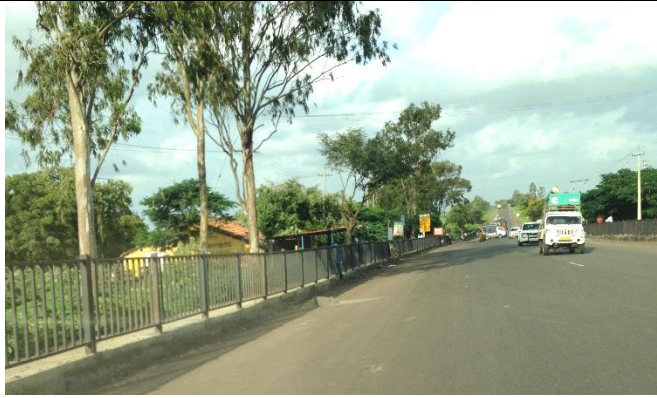
Location	Design feature	Image	Star Rating - Before	Star Rating - After
SH-20; Belgaum to Nesargi; 28.4km (from Belgaum)	New sidewalk with pedestrian fencing

<p>Vehicles: 2-star (18.0) Motorcyclist: 1-star (23.5) Pedestrians: 1-star (143.8) Bicyclists: 1-star (93.2)</p>

<p>Vehicles: 4-star (4.7) Motorcyclist: 3-star (5.6) Pedestrians: 5-star (0.2) Bicyclists: 3-star (21.1)</p>
SH-20; 6.4km	Raised (table-top) pedestrian crossing

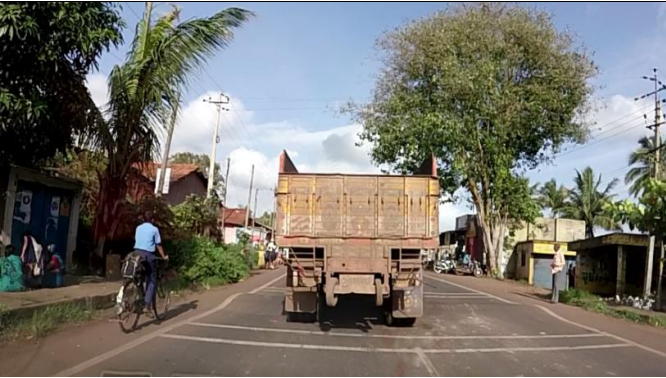
<p>SH-20; 15.2km</p>	<p>Traffic calming (road hump)</p>

<p>Vehicles: 2-star (17.8) Motorcyclist: 1-star (23.4) Pedestrians: 1-star (159.6) Bicyclists: 1-star (111.8)</p>

<p>Vehicles: 4-star (2.6) Motorcyclist: 4-star (3.2) Pedestrians: 3-star (18.4) Bicyclists: 4-star (7.8)</p>
<p>SH-20; 43.7km</p>	<p>Intersection (turn lane)</p>

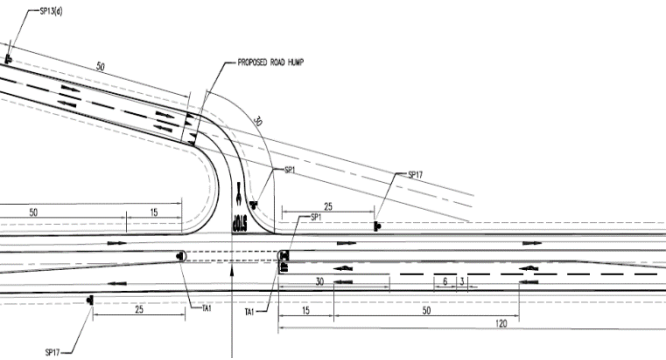
<p>Vehicles: 1-star (197.6) Motorcyclist: 1-star (255.8) Pedestrians: 1-star (573.3) Bicyclists: 1-star (445.8)</p>

<p>Vehicles: 3-star (9.8) Motorcyclist: 2-star (12.7) Pedestrians: 3-star (32.7) Bicyclists: 3-star (16.7)</p>
<p>SH-20; 26.7km</p>	<p>Roadside barrier</p>

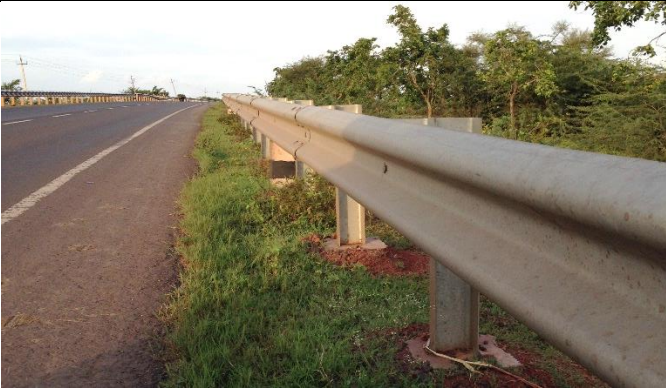
<p>Vehicles: 2-star (16.9) Motorcyclist: 1-star (39.5) Pedestrians: 1-star (74.4) Bicyclists: 1-star (234.7)</p>

<p>Vehicles: 3-star (6.5) Motorcyclist: 3-star (12.4) Pedestrians: 1-star (115.6)</p>
